Smoke Movement Through A Suspended Ceiling System

Final Report

SMOKE MOVEMENT THROUGH A SUSPENDED CEILING SYSTEM

John H. Klote

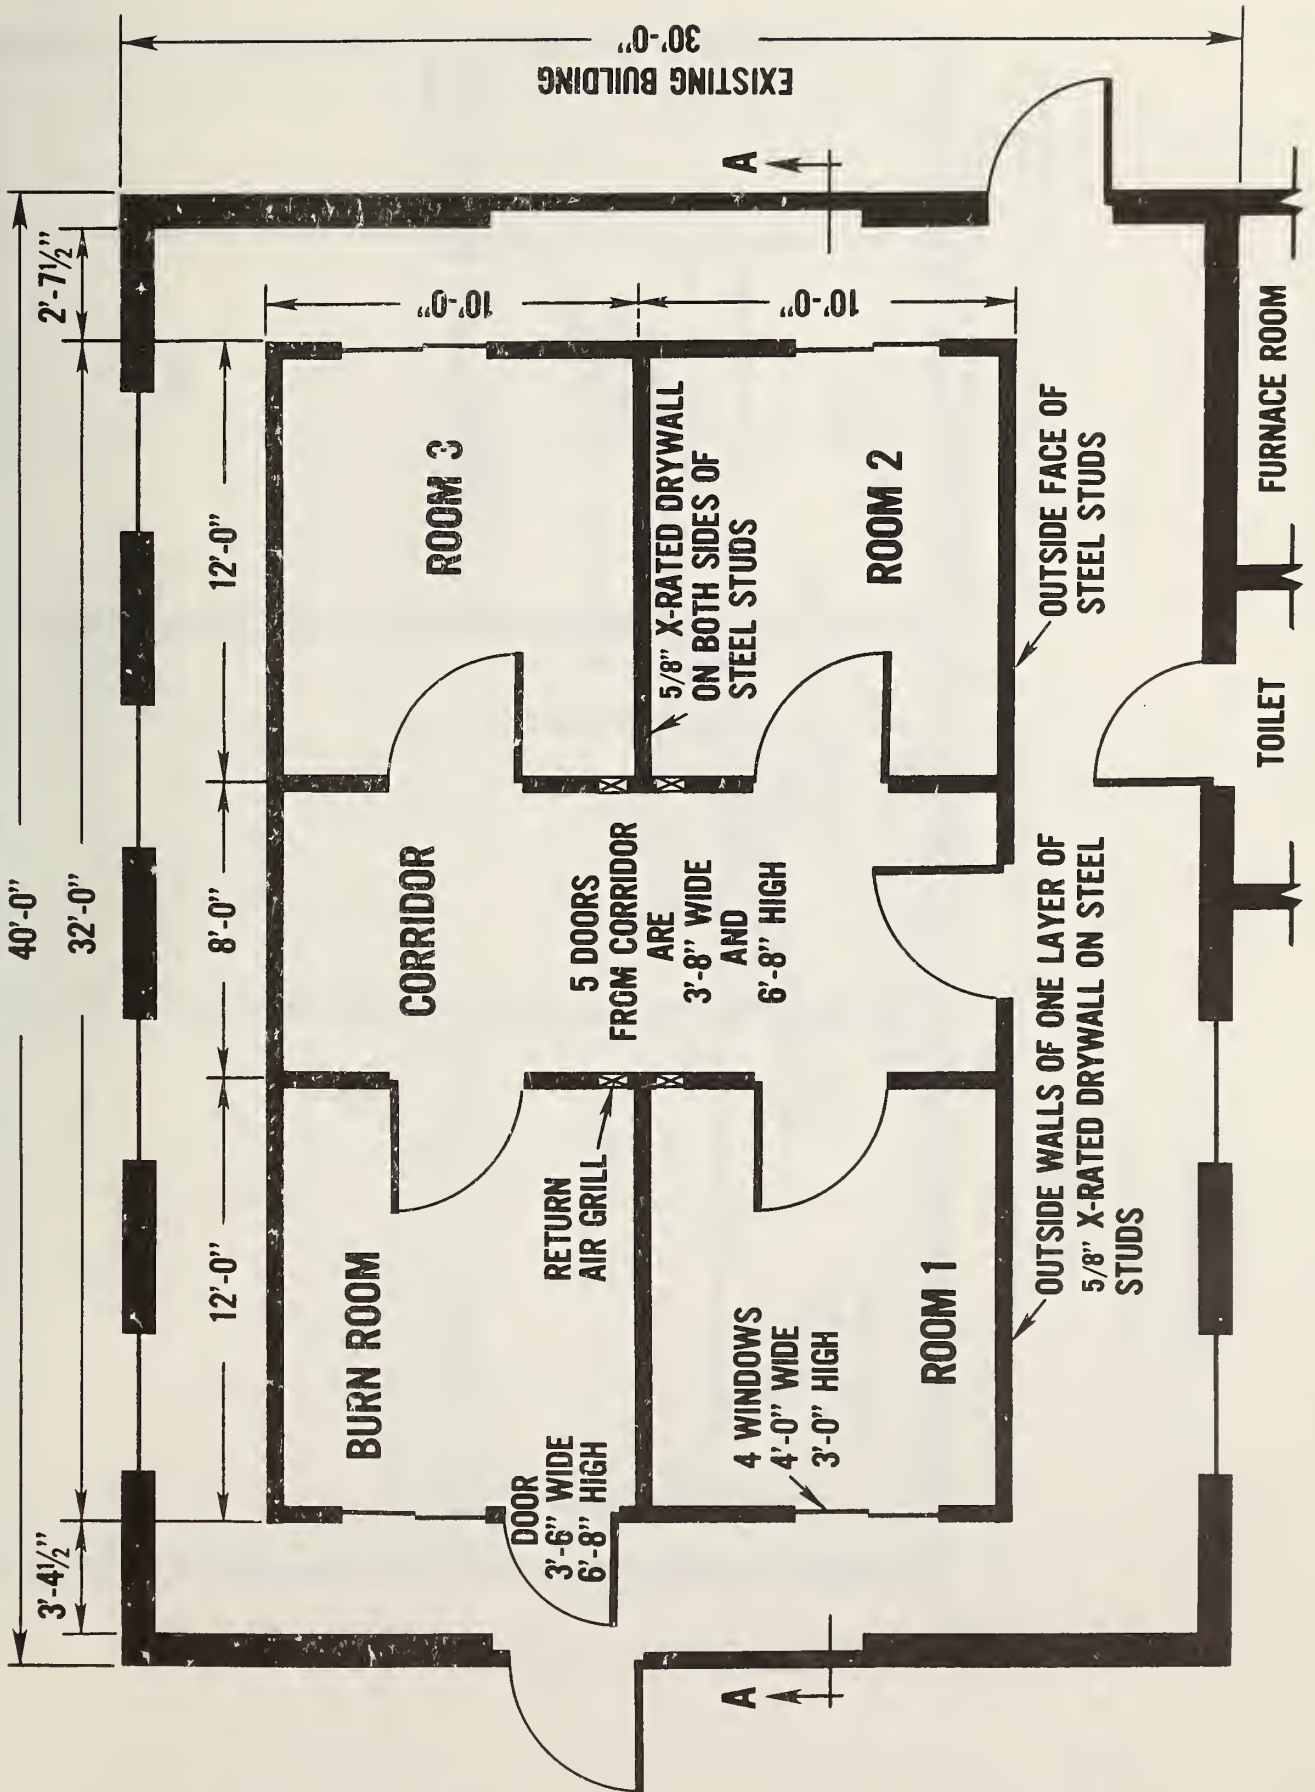
Figure 1. Floor plan of test facility

The test facility was built inside another structure to minimize the effect of the wind. This facility has four patient rooms and a section of corridor as shown in figure 1. The burn room has one door to the corridor and another smaller door to the space outside the test facility. This smaller door was included to provide a convenient exit. This door was closed throughout all the tests except for the first 5 to 10 seconds of each test when the person who ignited the test fire was exiting. Reference in this report to the "burn room door" will mean the door between the burn room and the corridor.

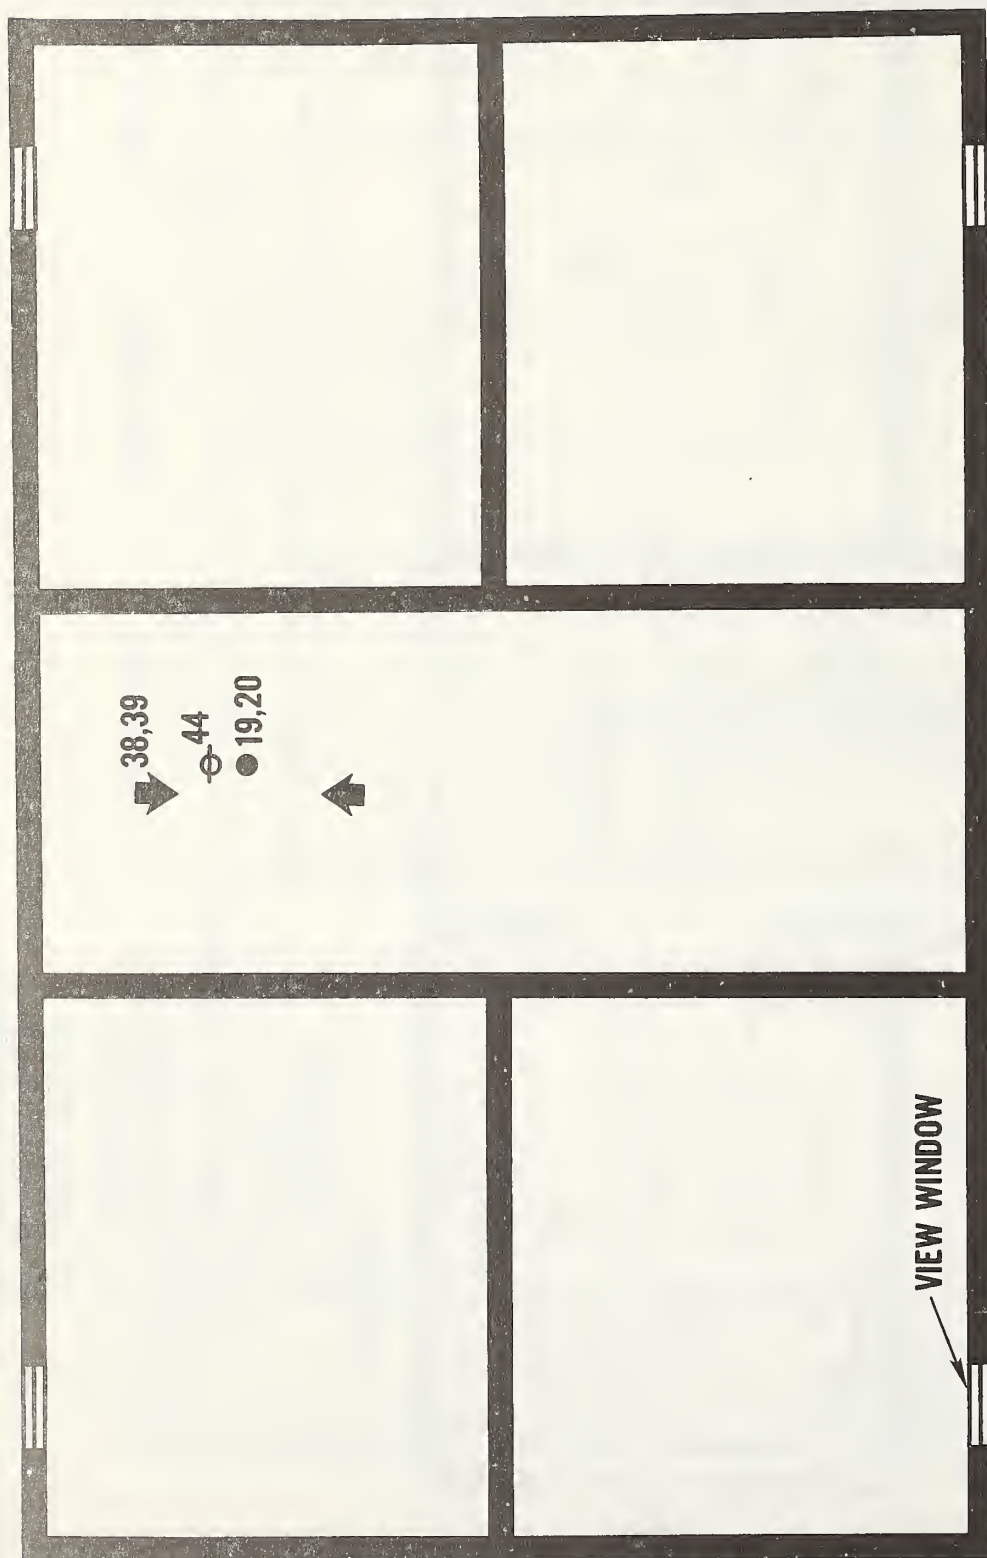
Figure 6. Instrumentation plan for interstitial space

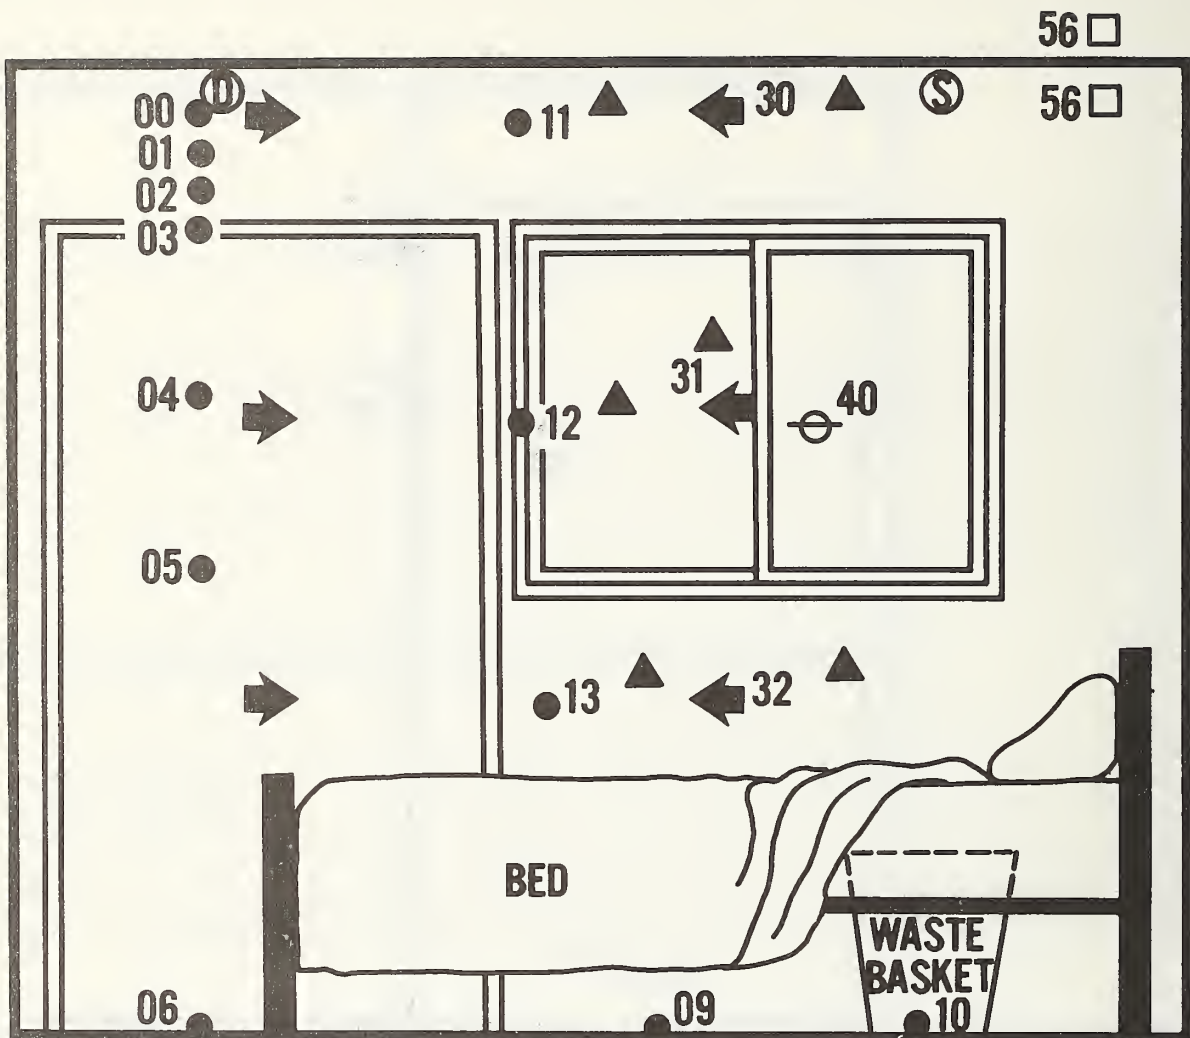
Figure 8. Instrumentation in burn room

Figure 29 shows the pressure difference across the burn room ceiling (see instrument number 56 on figure 8). For this figure a positive pressure indicates that the burn room is at a higher pressure than the interstitial space. It can be observed from figure 29 that in

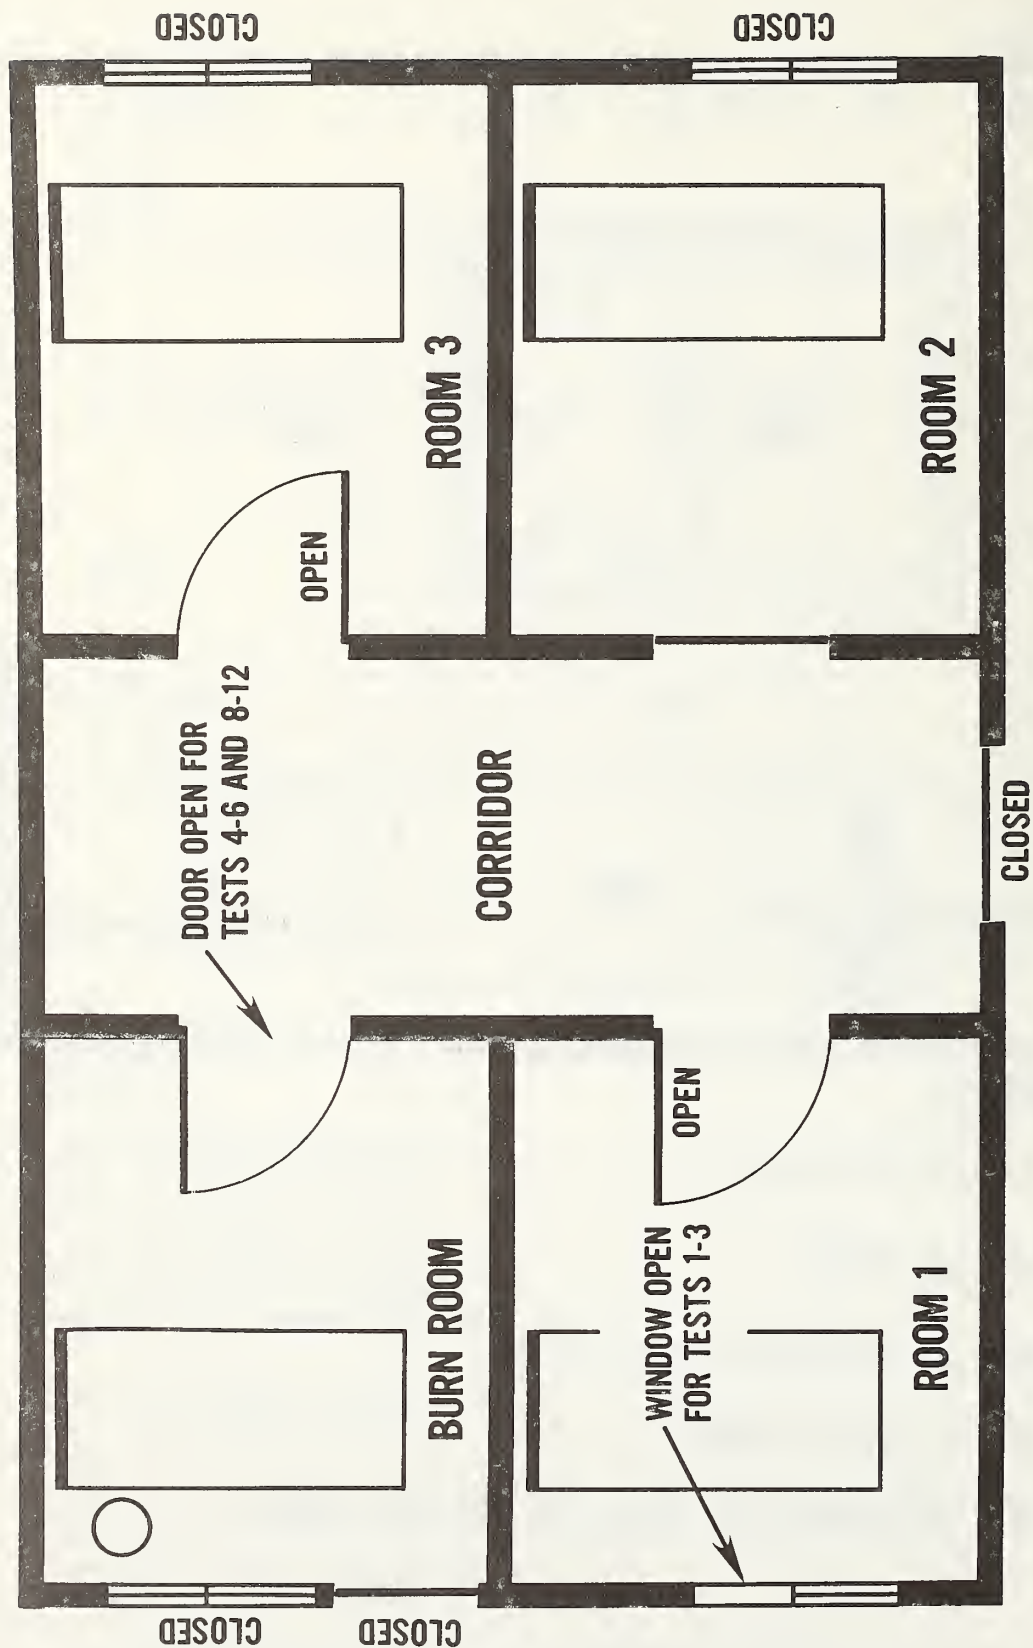
Figure 10. Floor plan for test facility showing status of doors and windows during the tests

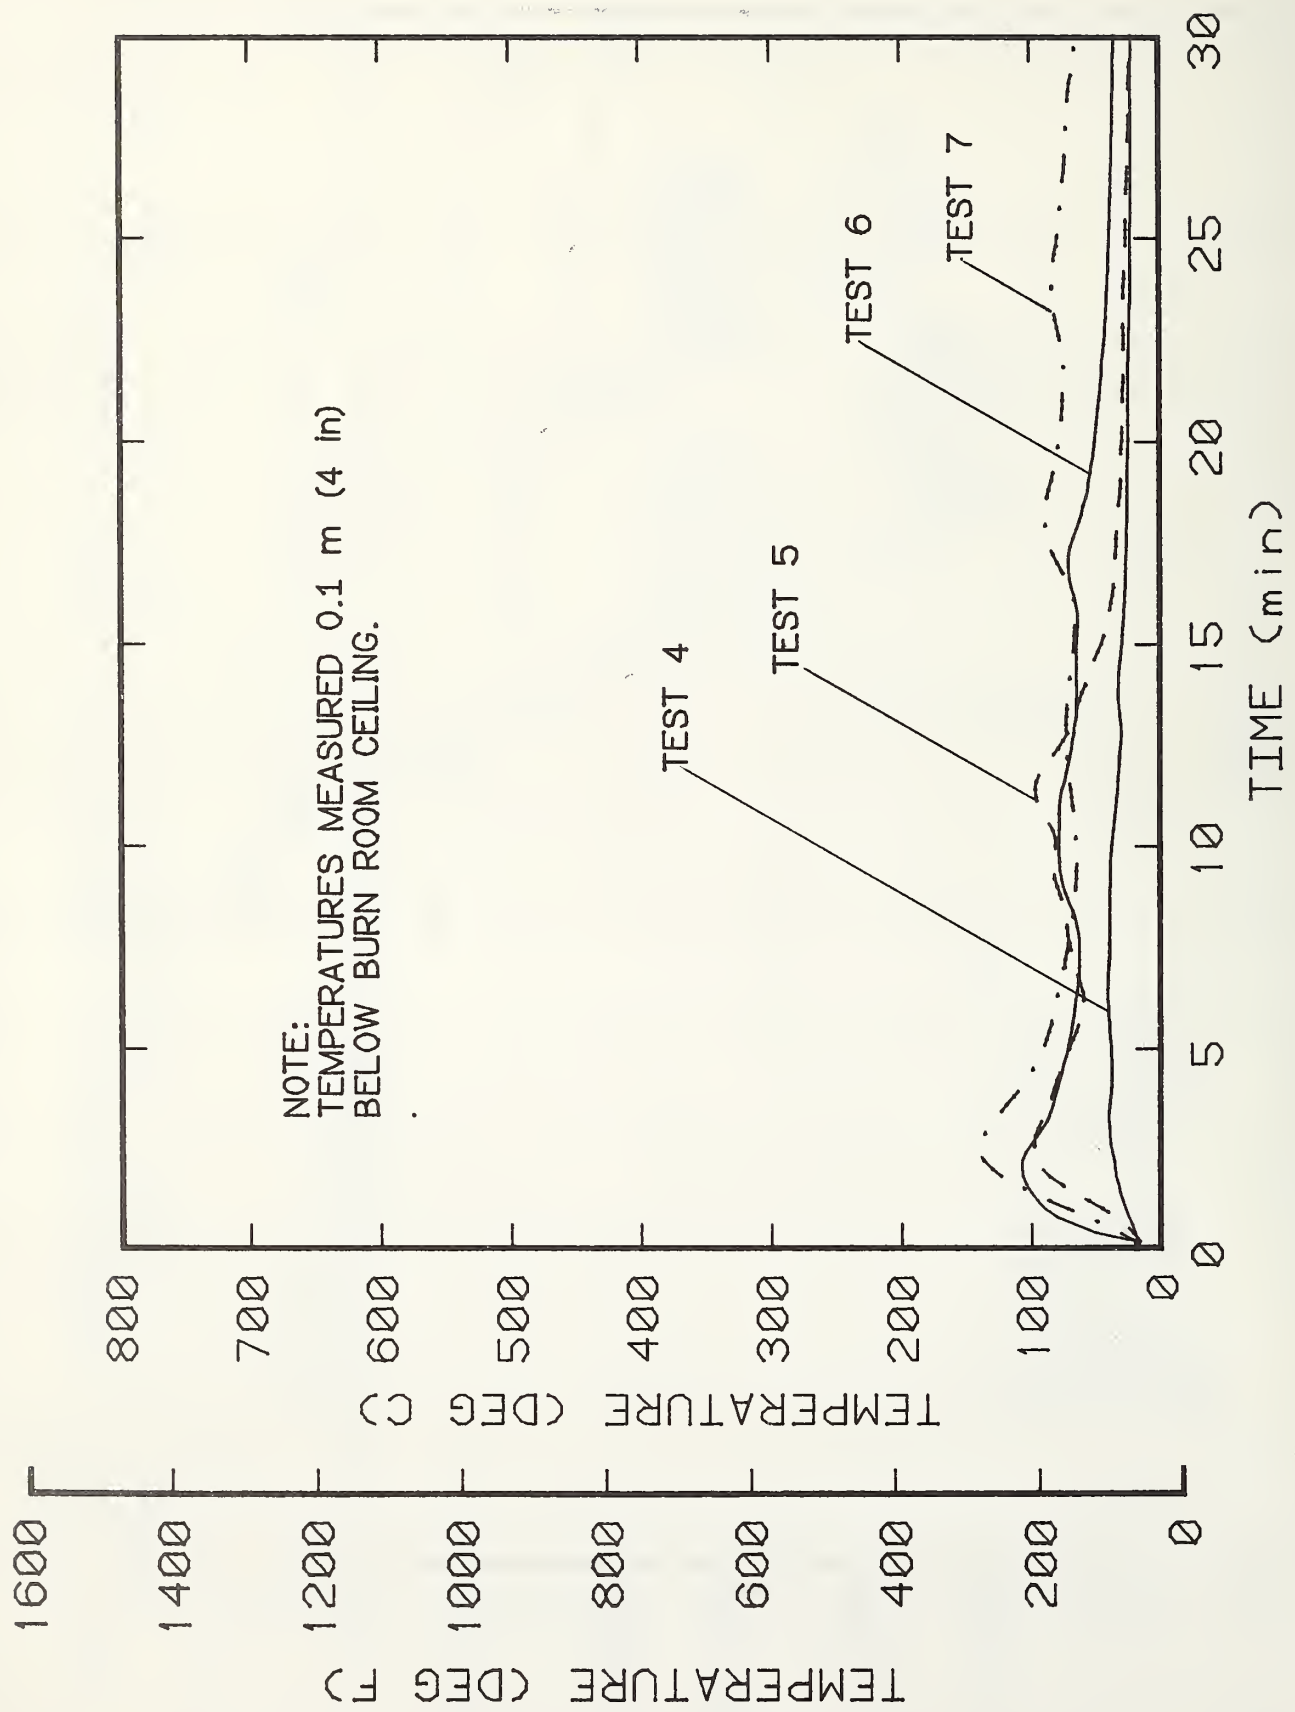
Figure 14. Upper gas temperatures for tests 4 through 7.

In tests 4 through 10, fire retardant cotton mattress and bedding as described in section 3.4.1 were burned. The test conditions for these tests are summarized in table 3. The burn room door was open for all tests, with the exception of test 7. The window in room 1 was closed for all tests for reasons discussed in section 5.2.2. The status of all windows and doors for these tests is provided in figure 10. Figures 14 and 15 show the upper gas temperatures in the burn room for these tests.

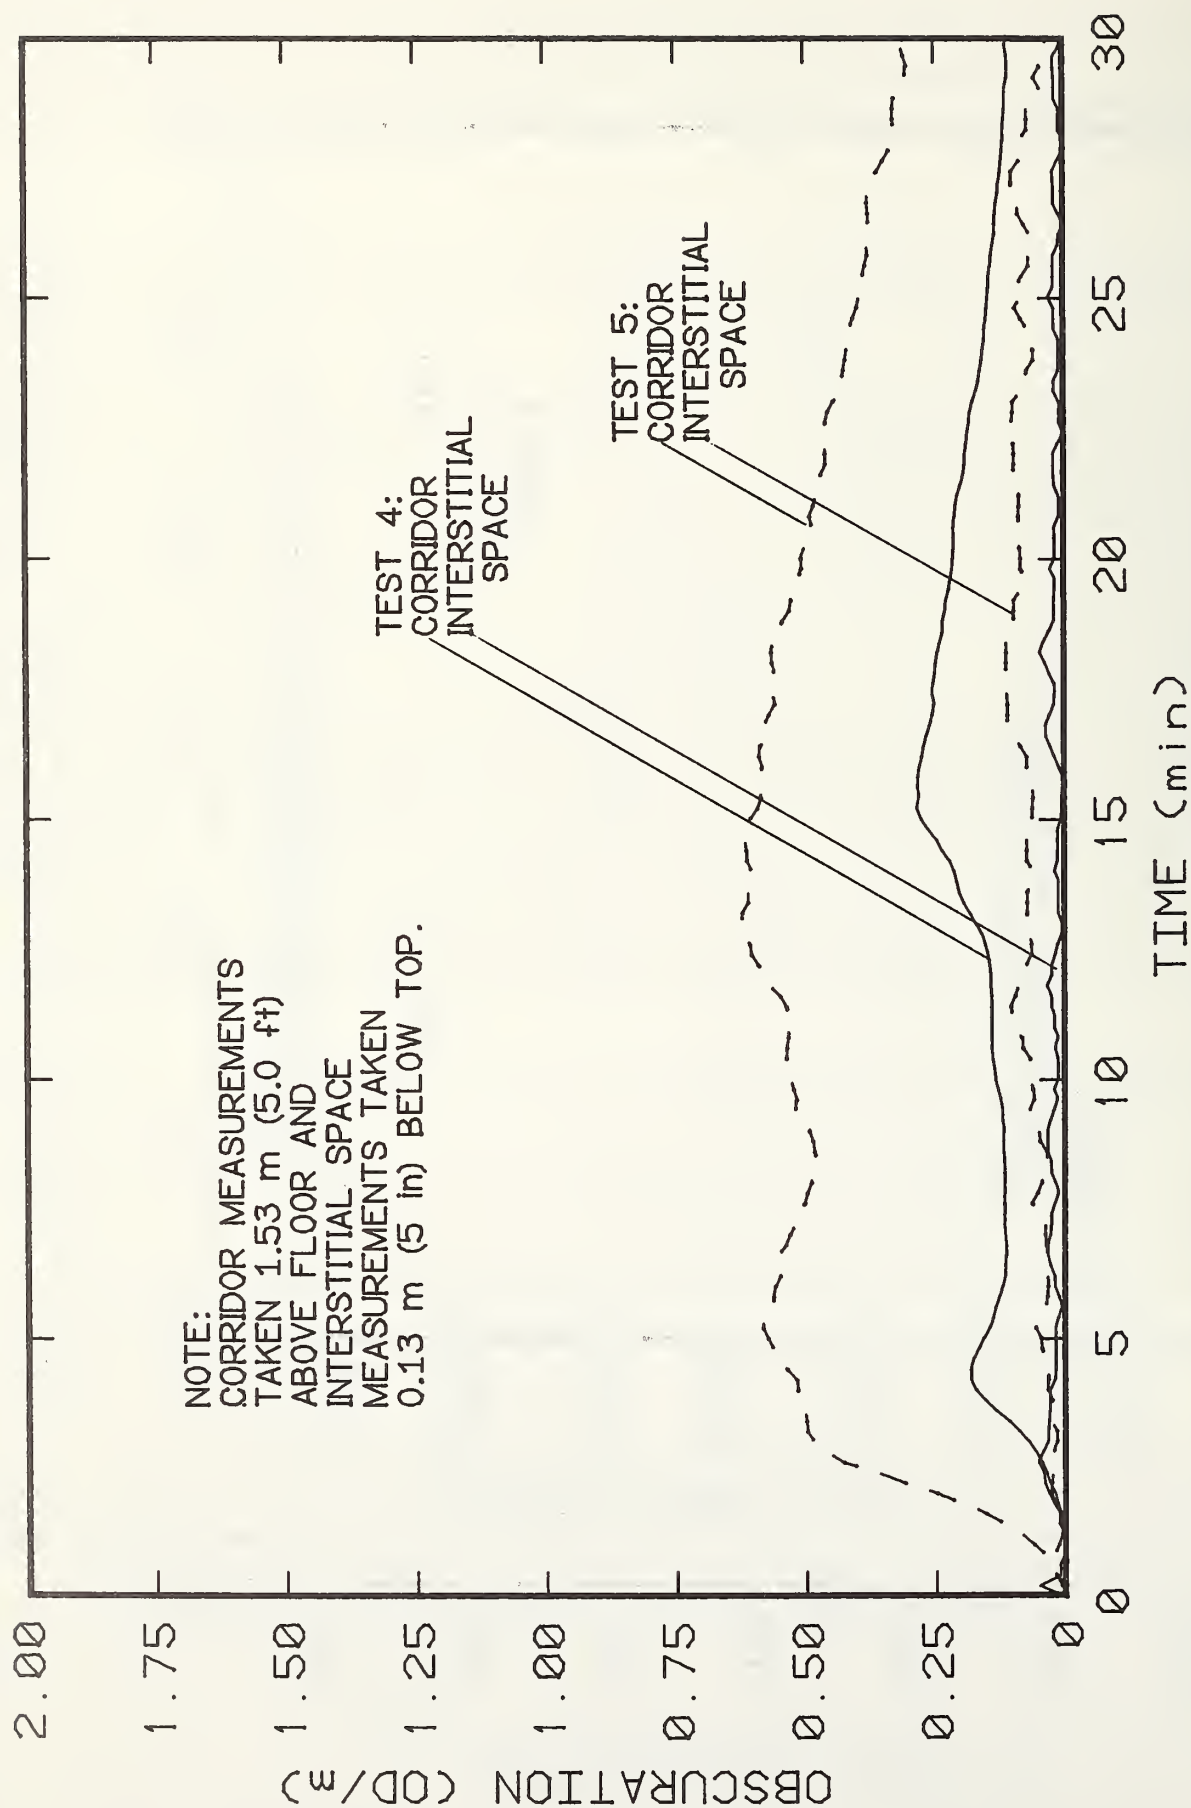
Figure 16. Smoke obscuration for tests 4 and 5.

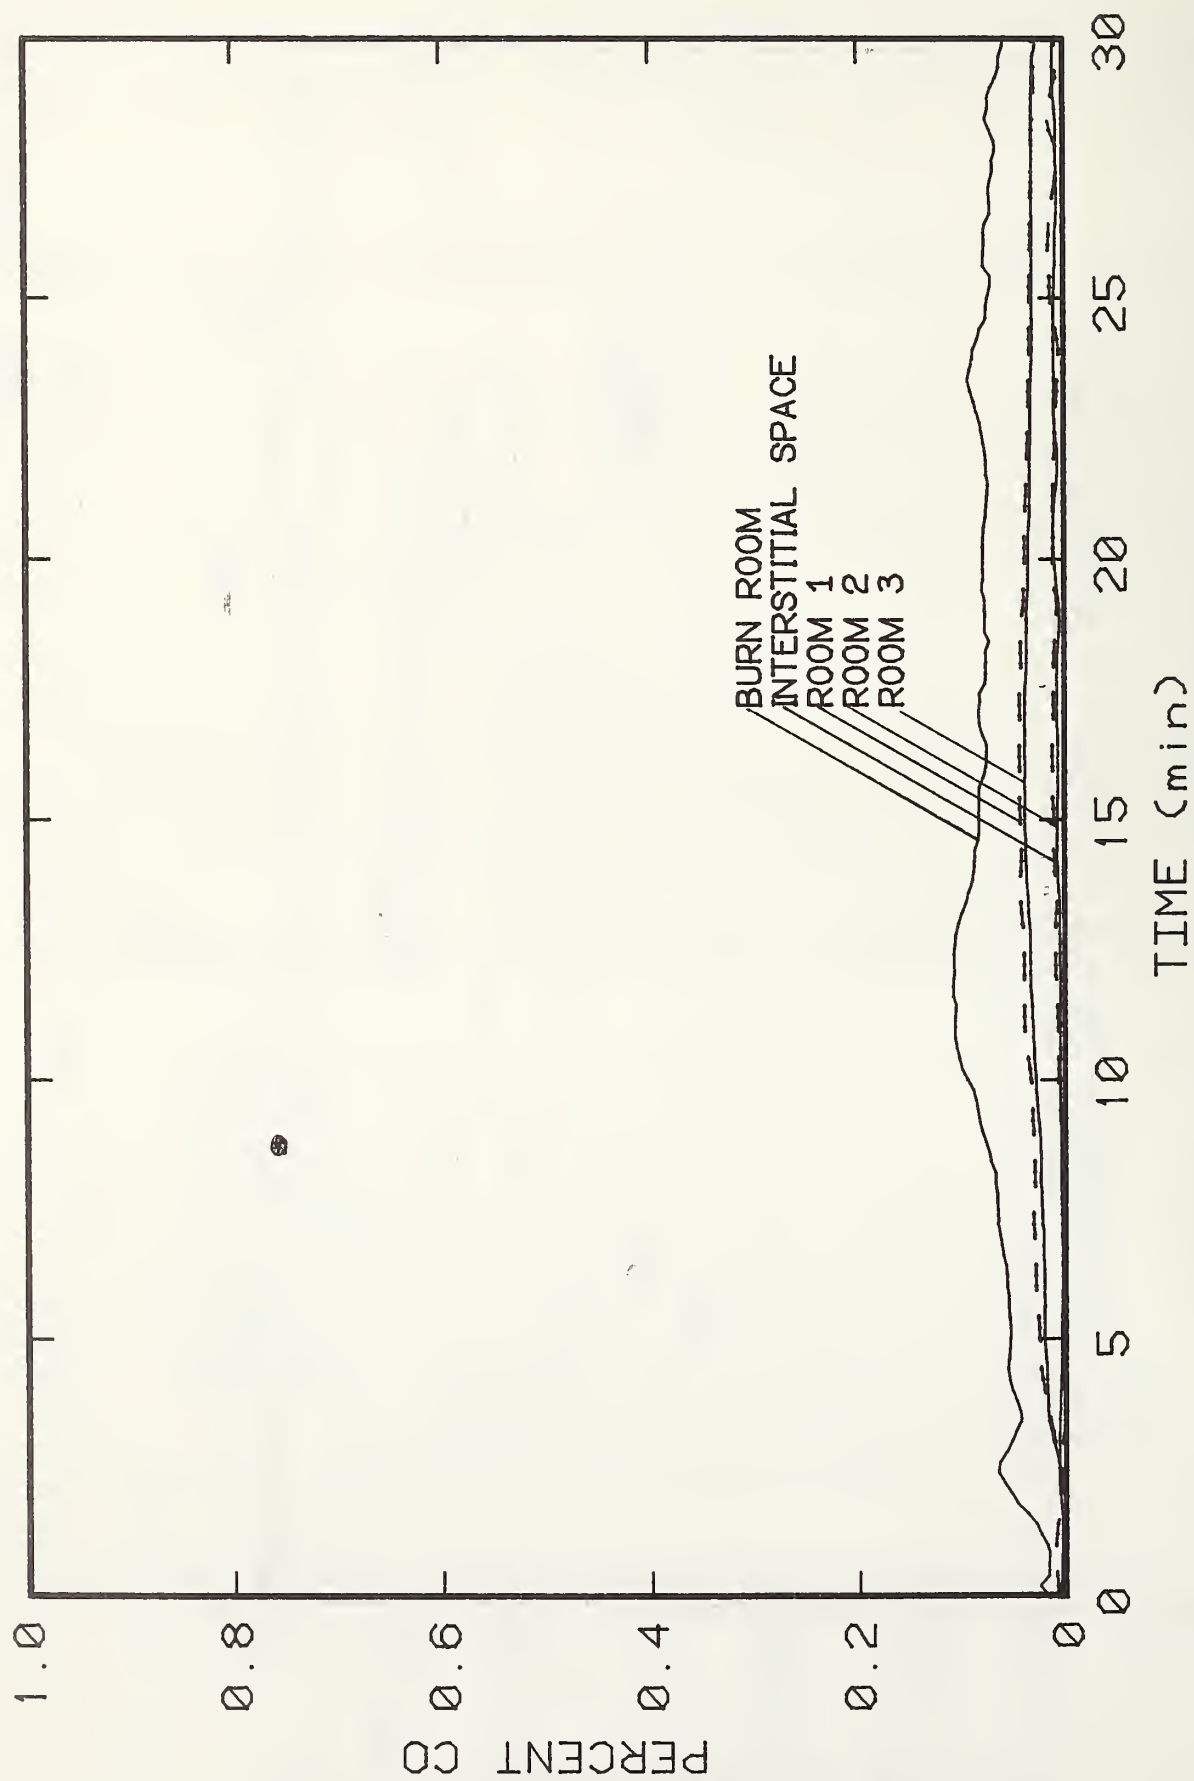
Figure 18. Carbon monoxide concentrations for test 5.

Similar observations regarding smoke movement can be obtained by examining CO concentration. Figure 18 shows CO concentrations for test 5. The CO concentrations in the burn room, and rooms 1 and 3 were relatively high, while the concentrations in room 2 and the interstitial space are negligible. It can be observed from figure 18 that the burn room concentration of CO is about twice that measured in rooms 1 and 3. This is because the burn room CO probe samples the gas from the fire plume.

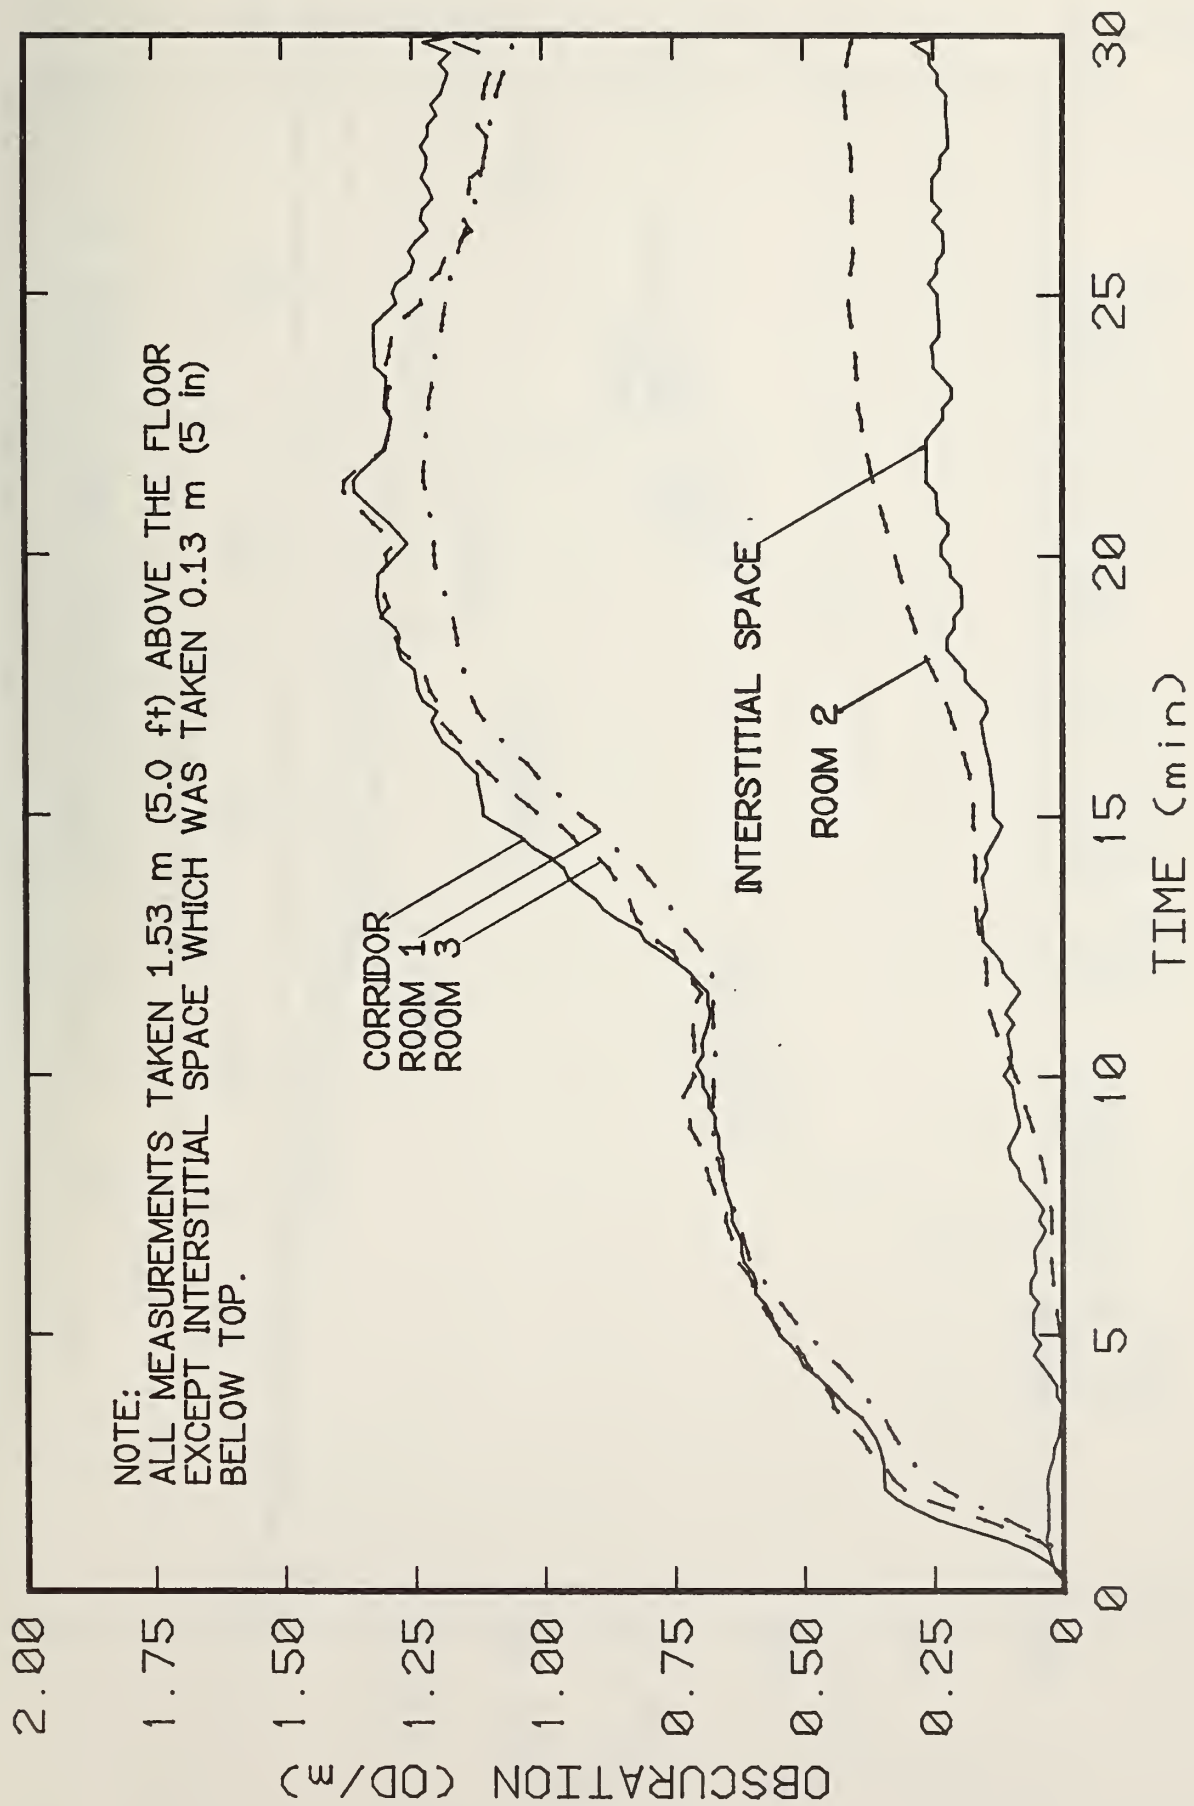
Figure 19. Smoke obscuration for test 6.

The test conditions for test 6 were the same as those for test 5 except that the supply air and the return air were shut off. This test was conducted to determine the extent to which smoke obscuration would increase without ventilation. Figure 19 shows smoke obscurations for test 6. As in test 5 the optical density in the corridor and rooms 1 and 3 increased rapidly while the optical density in the interstitial space and room 2 was much lower. As in test 5 it is apparent that the smoke flow through the open doorway was much greater than the upward smoke flow through the ceiling system. There were no indications of smoke flowing from the interstitial space into room 2.

Test 7 was conducted to determine the effect of a closed burn room door on smoke concentration. This test was the same as test 6 except for the closed door. Figure 20 shows smoke obscurations for test 7. By comparing figures 19 and 20 it is apparent that closing the burn room door significantly reduces the smoke obscuration in the corridor and in rooms 1, 2, and 3. However, these figures also show that closing the burn room door has essentially no effect on smoke obscuration in the interstitial space. This is probably because the major path of smoke movement into the interstitial space is through the burn room ceiling in either case. In addition, there were no indications of smoke flowing from the interstitial space into room 2.

interstitial space. Accordingly, the level of smoke in the corridor and patient rooms would decrease. Figure 22 shows smoke obscuration for test 8. In comparing the results of tests 6 and 8 (figures 19 and 22), it is apparent that exhausting the interstitial space did indeed result in reduced smoke obscuration in the corridor and in rooms 1, 2, and 3. Unfortunately, this reduction in obscuration did not result in greatly reduced hazard conditions. It can also be noticed by comparing figures 19 and 22, that exhausting the interstitial space had little effect on the smoke obscuration in the interstitial space. In this test, as in earlier tests, smoke was observed leaking into room 2 through the crack under the door. It should be noted that there were no indications of smoke flowing from the interstitial space into room 2.

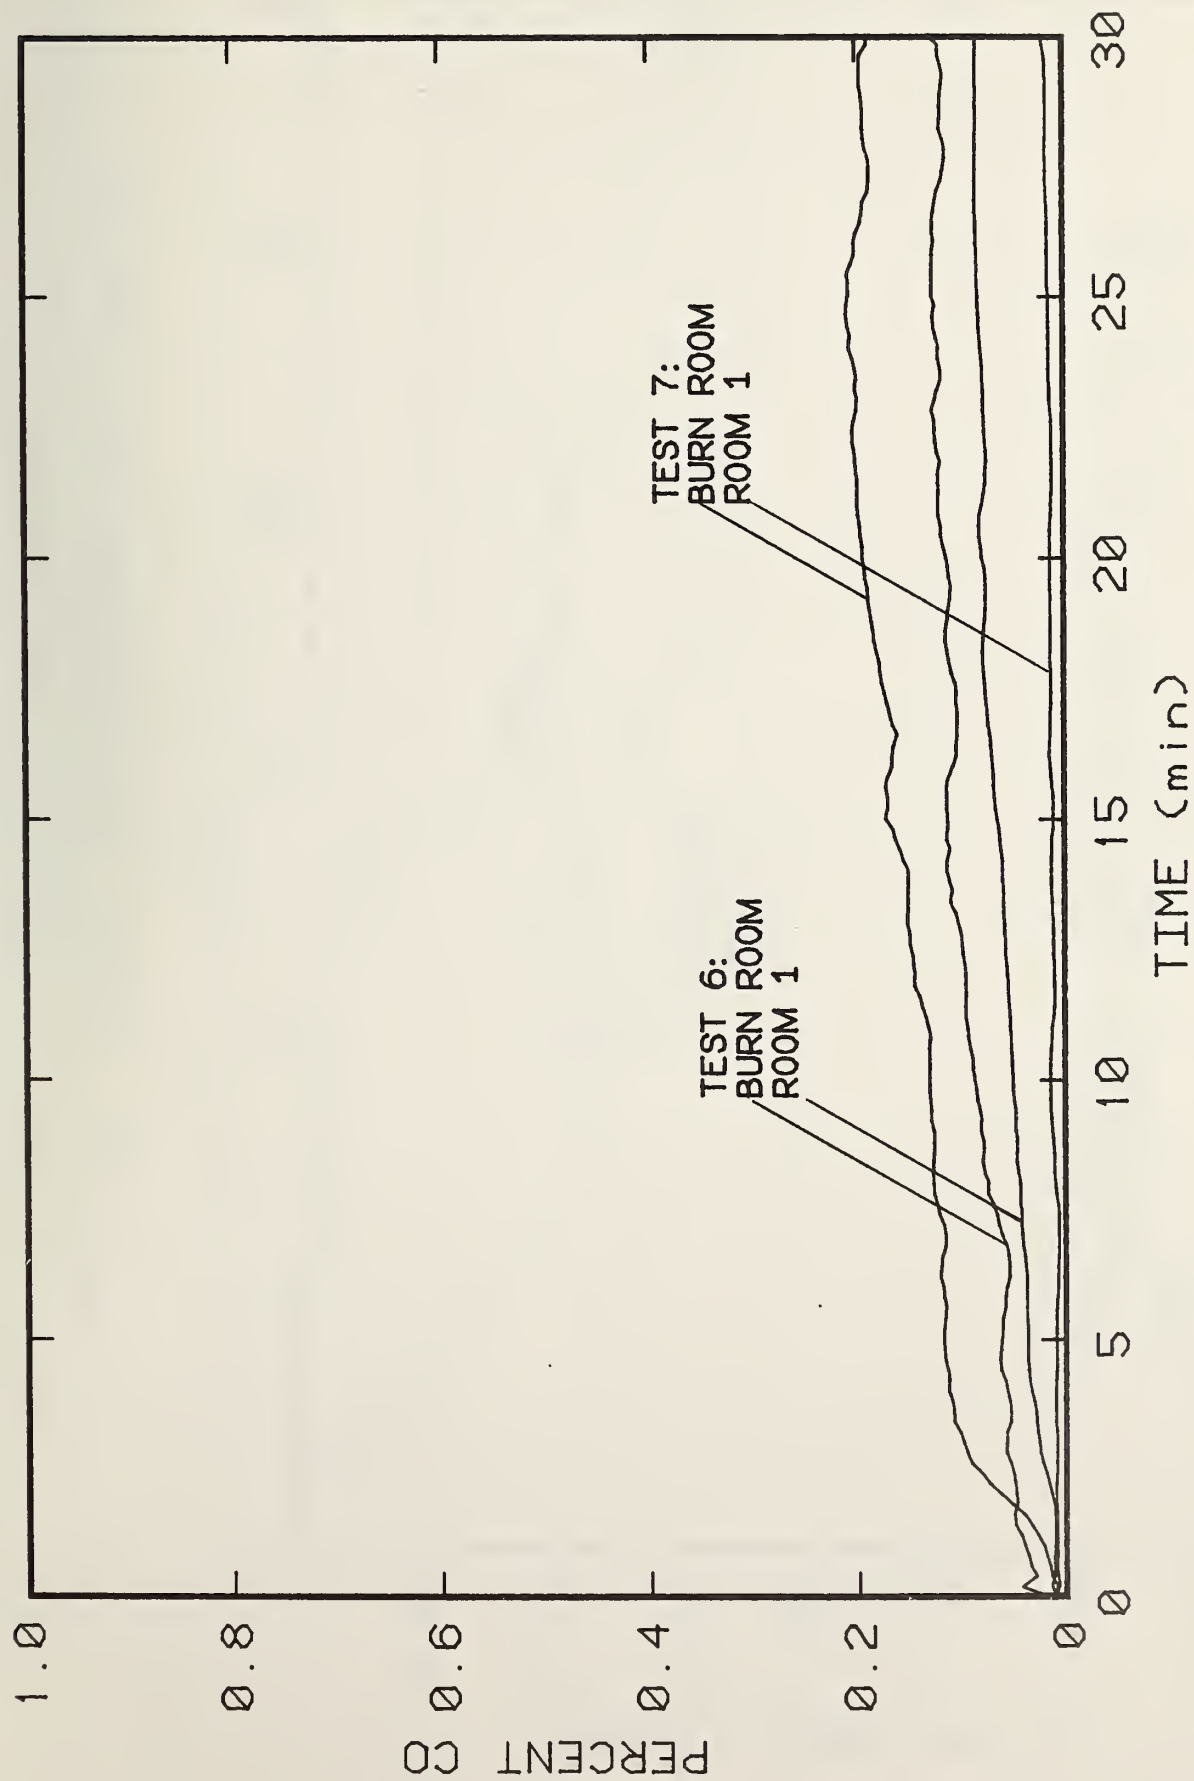
Figure 21. Carbon monoxide concentrations for tests 6 and 7.

Figure 21 shows CO concentration in the burn room and in room 1 for tests 6 and 7. This data shows that closing the burn room door results in increased CO in the burn room and decreased CO in room 1. The burn room CO concentration is increased to the extent that in test 7 the critical level of COHb is reached in 22.6 minutes. However, in all the other low energy tests where the burn room door was open the critical level was not reached.
